SUSTAINABLE FISHERIES MANAGEMENT PROJECT (SFMP)

Progress Report For The Rehabilitation Of The CEWEFIA Fish Processing Center

SEPTEMBER 18, 2017

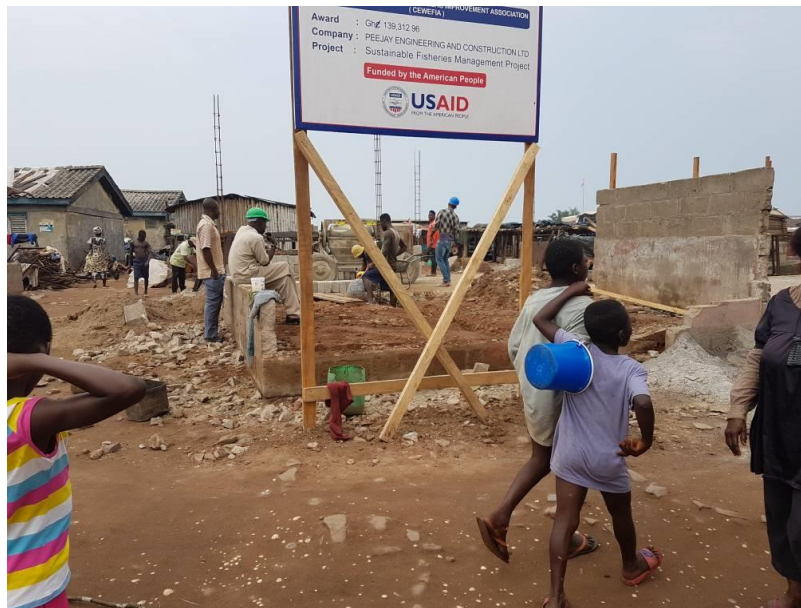
Figure 1 Construction Site

The site was handed over officially to the contractor, Messer Peejay Engineering & Construction Ltd on July 17, 2017 for work to be completed in 90 days (by 17th October, 2017). However, a series of misunderstandings ensued with the local stakeholders on bordering the construction zone (for safety and security reasons), removal of certain assets (firewood and the local fish drying structures) that led to delays as meetings had to be held between all stakeholders, with compromises and a resolution reached by all parties to enable work move on. This included the revision of the toilet location from what was designed and planned to fit with the resolution made between all stakeholders. This process took about 2 weeks to accomplish and as such the contractor did not officially start work on the rehabilitation till July 31, 2017. Thus construction commenced on 30th October, 2017 and accounted for the delay.

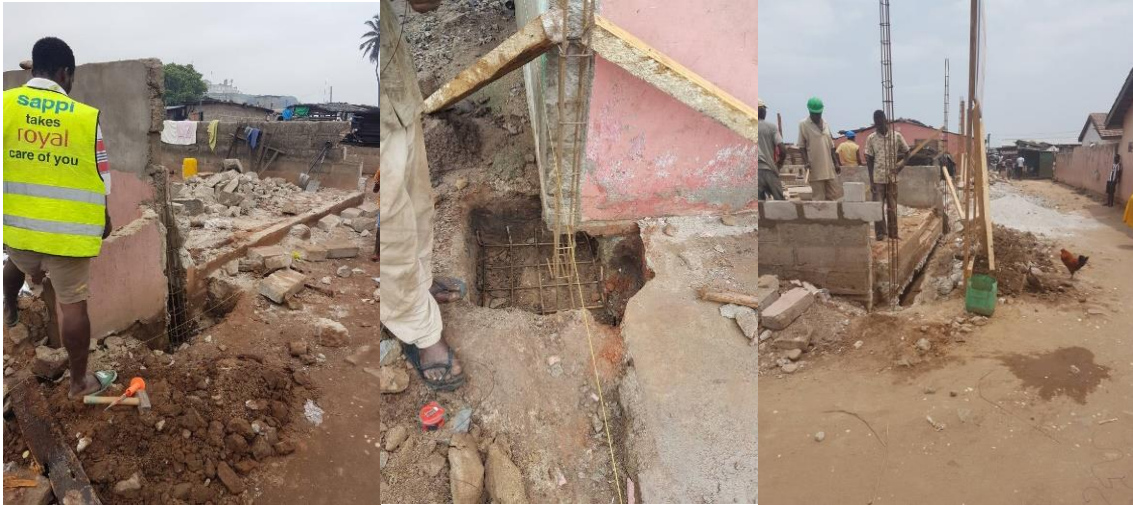
Figure 2 New structure being laid

When work started it was noticed that the previous foundation works had not been properly done, contributing to making the structure unsteady. Consultation with the contractor resulted in a major part of the foundation to be redone; so as to allow for preventive measures initially recommended for the rehabilitation to have a more meaningful and lasting structure. (See pictures below)

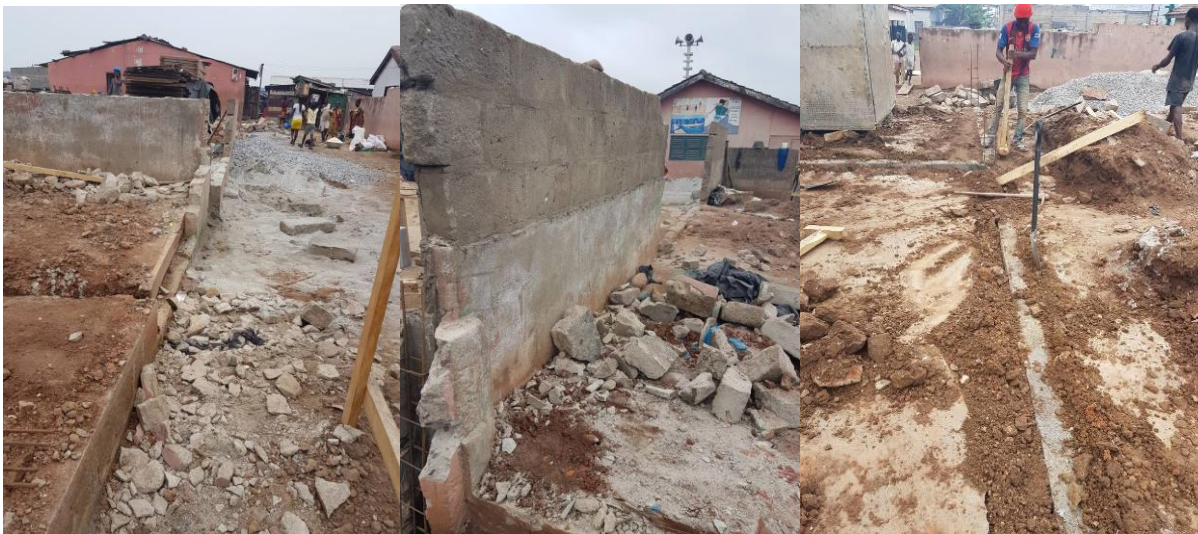
Figure 3 Walls removed as well as column structure being laid

In doing so, large sections of the existing walls needed to be removed and re-laid before the wood support columns could be reintroduced as was initially planned and designed (See pictures below).

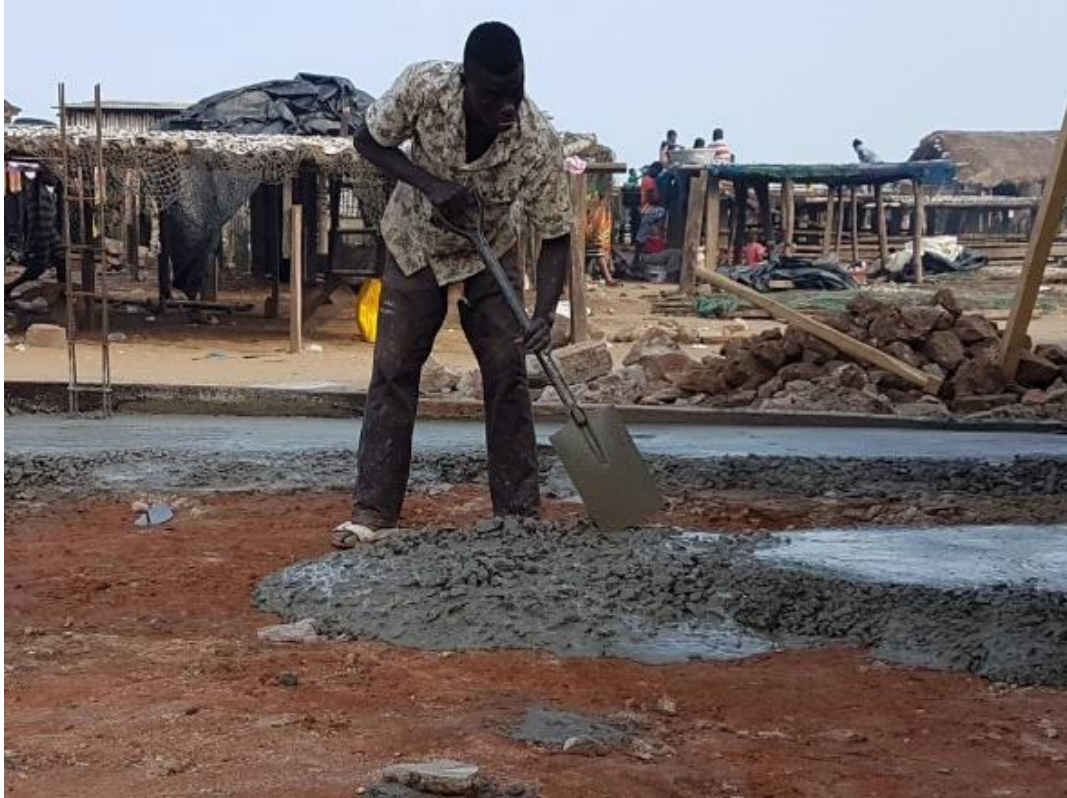
Figure 4 Flooring being laid

As a result of all these reinforcements done, the previously laid flooring, that was only about 2 inches screed finish needed to be redone completed with a proper concrete flooring (approx. 5in concrete base) before cement screed flooring was done as final finish. (See picture below)

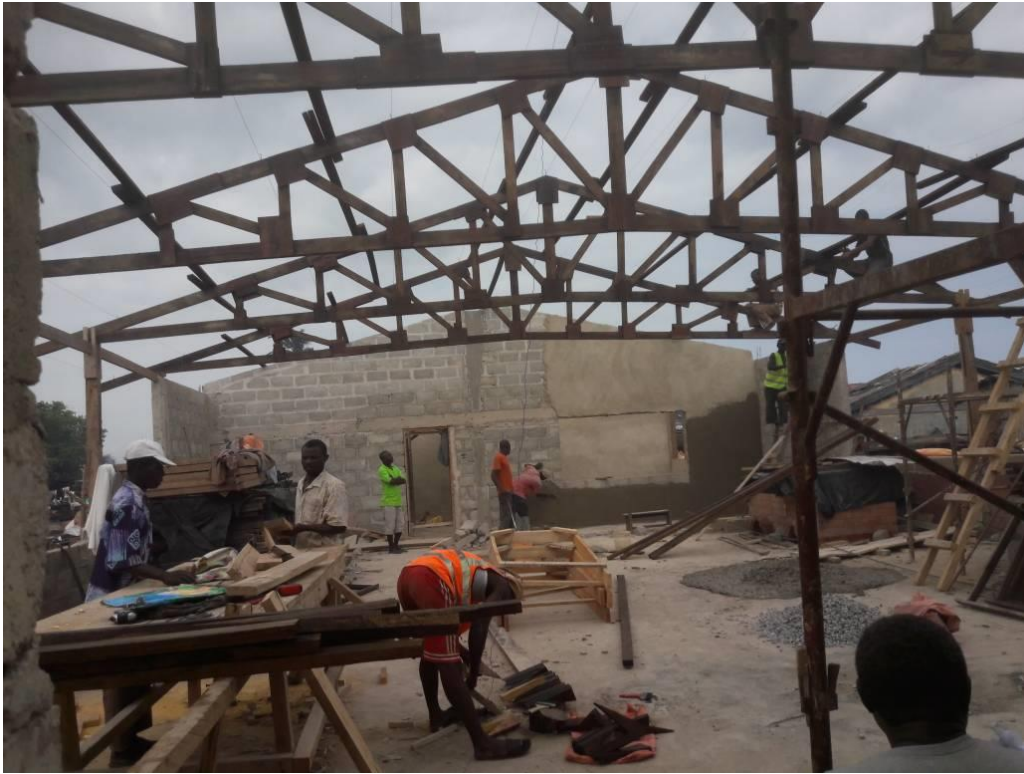
Figure 5 Inside Structure on September 9, 2017

Work has been steadily moving along since commencement of construction and currently the work is about 60% completed (See pictures below). At the rate at which works are going the contractor is on course to finish before or on the deadline date of 30th October 2017, barring any unforeseen circumstances.
